### 25 HP Swan

- Manufactured 1901, Lima, Ohio, by The John W. Swan Co.
- Engine Specs: 25 HP, 12-1/4-inch bore by 18-inch stroke, 69-inch flywheels.
- 4-cycle "T" head, crosshead, sideshaft, vertical flyball governor.
- Mechanically actuated intake and exhaust valves.

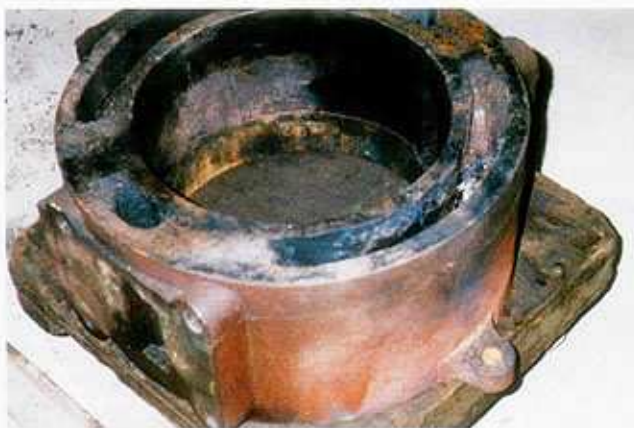
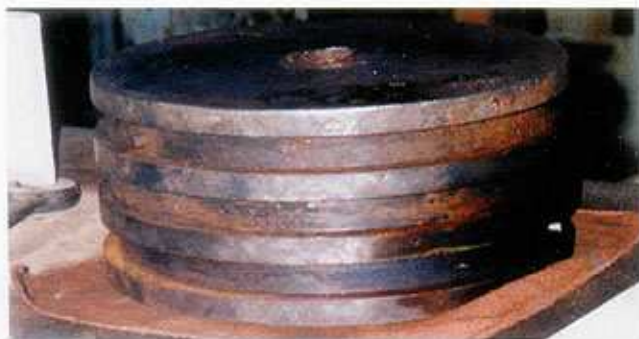
The Swan's combustion chamber after disassembly (left) and piston (above).

The cylinder sleeve, combustion chamber, head and cover plate are mounted to the engine bedplate and held together by six, 38-inch-long tie rods. I removed the tie rods first, and then the cylinder head cover plate came off. The cover plate, which has the engine's manufacture information, horsepower and serial number cast into it, is a thing of beauty. The head, unfortunately, was badly stuck to the combustion chamber. By applying heat and driving thin chisels between the head and the combustion chamber the head finally let loose, followed by the combustion chamber – complete with piston.

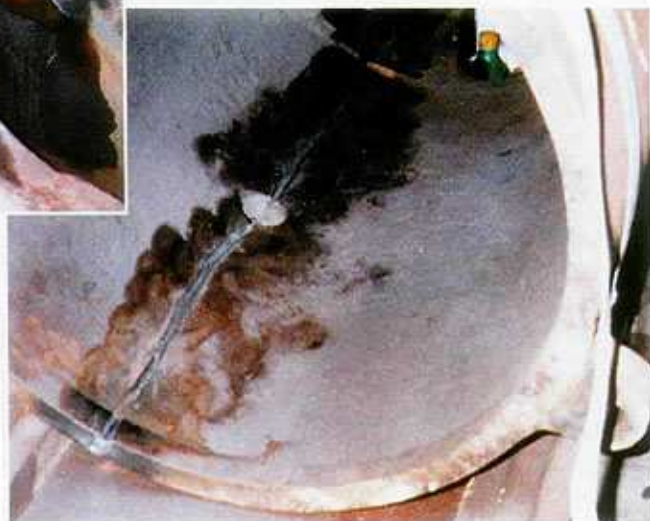
Below: Freeze crack ran the entire length of the cylinder water jacket.
