25 HP Swan

- Manufactured 1901, Lima, Ohio, by The John W. Swan Co.
- Engine Specs: 25 HP, 12-1/4-inch bore by 18-inch stroke, 69-inch flywheels.
- 4-cycle "T" head, crosshead, sideshaft, vertical flyball governor.
- Mechanically actuated intake and exhaust valves.

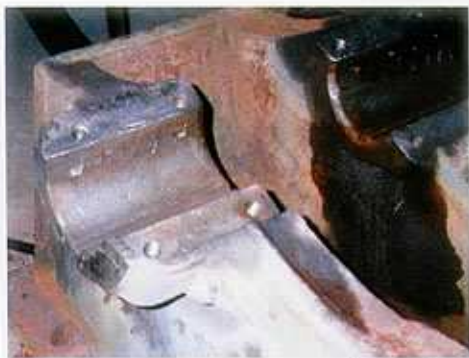
Left: A main bearing saddle prior to rebabbitting.
