Bedplate and Babbitting

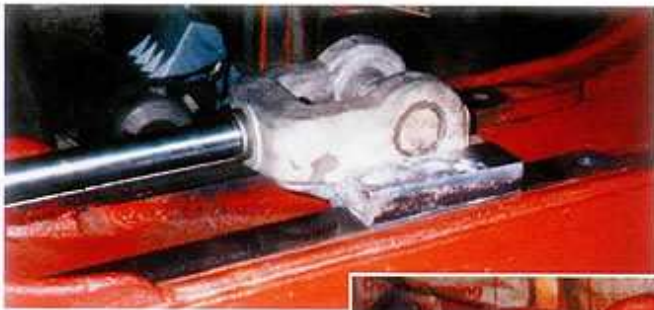
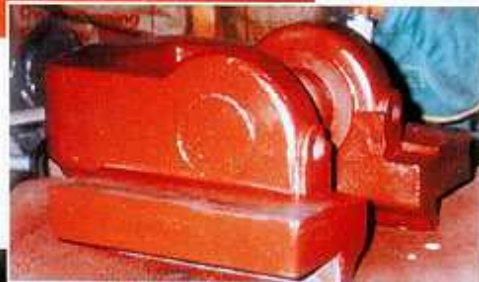
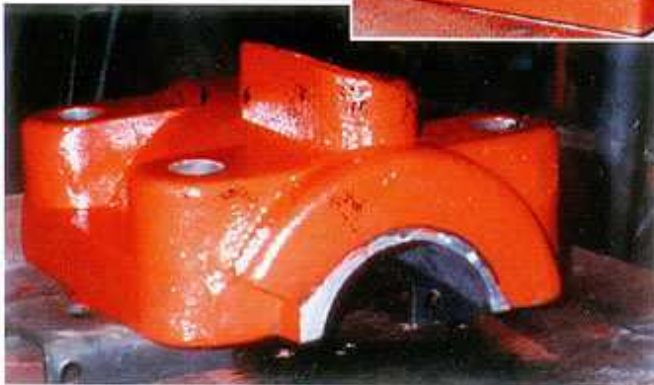
Crosshead after pouring new babbitt (above) and after a coat of primer (right). A freshly babbitted and primered bearing cap (below).

Next, I worked on getting the rest of the engine dismantled. The crosshead top rails and the crosshead came off without a problem. After removing the crankshaft and flywheels, I decided to re-pour the main bearings. They might have been useable, but I went ahead and melted out the original babbitt, forcing me to pour new ones. This way I didn't have to think about it. In the time I spent thinking it over I could have had them poured. I cleaned up the crankshaft bearing surfaces and prepped everything for pouring new babbitt bearings.

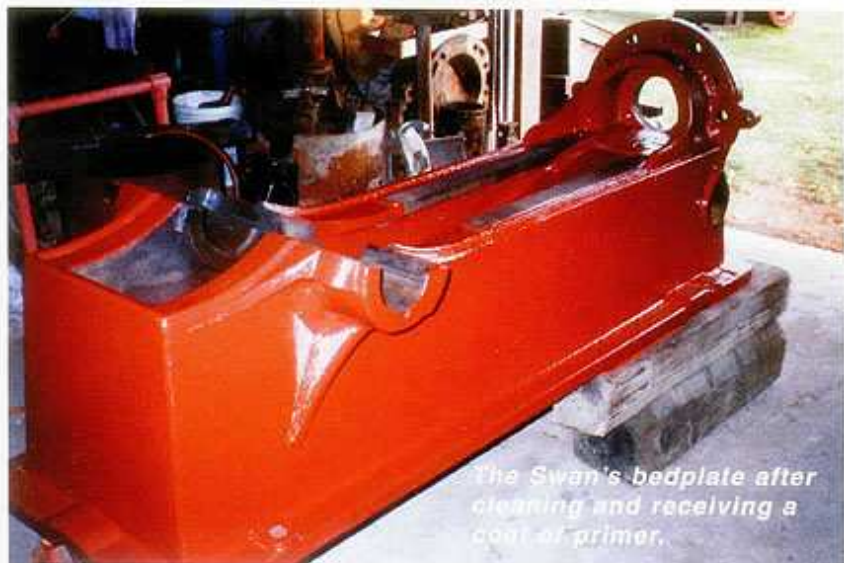
The Swan's bedplate after cleaning and receiving a coat of primer.
