Cracking Issues

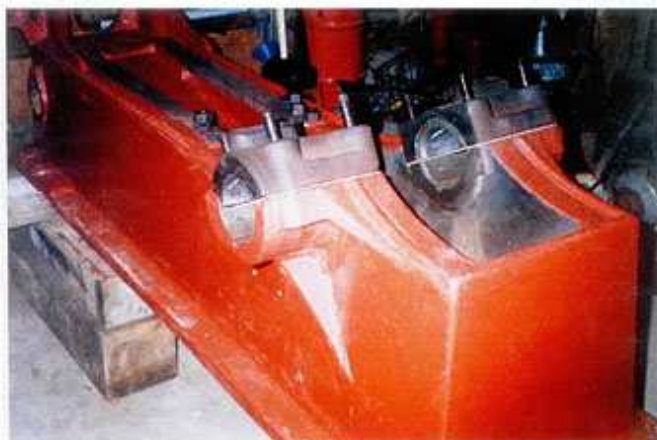
The Swan's bedplate and main bearing caps are fitted and ready for rebabbitting.

I poured the bearing caps and then put in some hard work cleaning up the bedplate to ready it for primer. I cleaned and sanded the crosshead slide surfaces, removing most of the pits, and I cleaned out or chased all the threaded holes in the bedplate with a tap. I also made new studs for mounting the crosshead top rails. Then I applied a couple of primer coats to the bedplate.

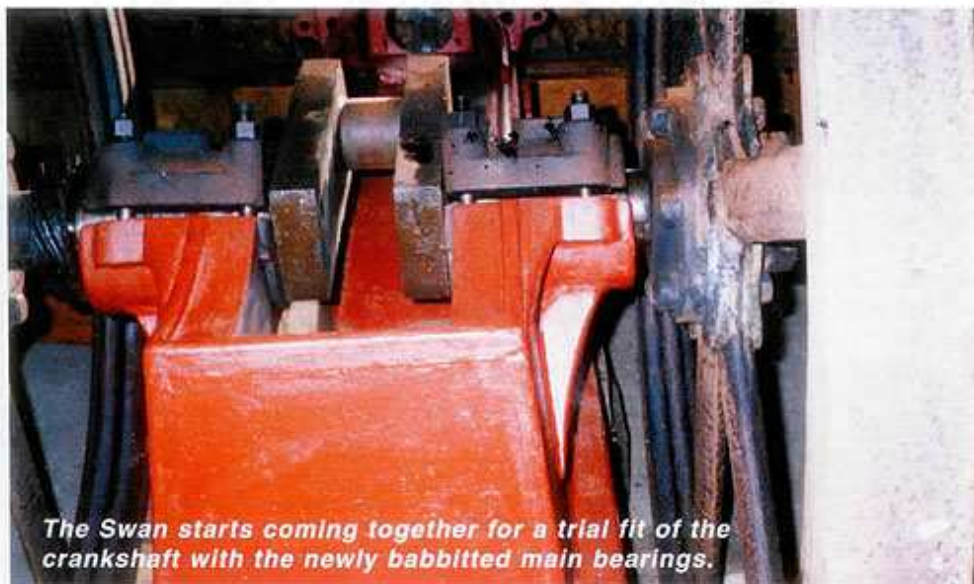
The Swan starts coming together for a trial fit of the crankshaft with the newly babbitted main bearings.
