Fresh Air and First Fire

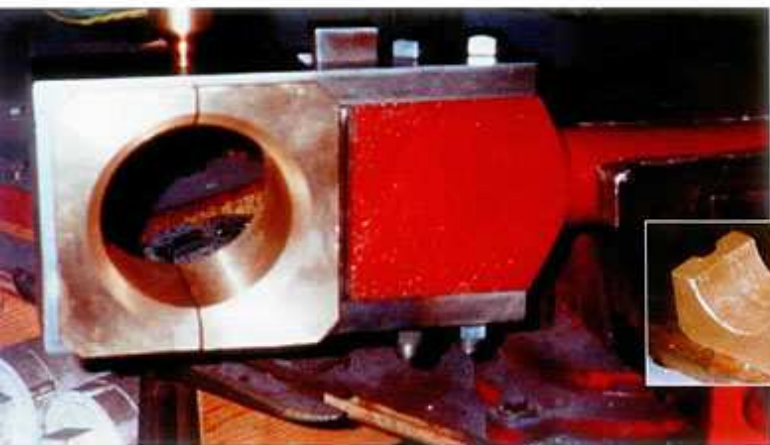
Left: Newly fabricated big-end bearings and strap for crosshead connecting rod and fresh bearing castings prior to final machining (inset).

Bottom: The Swan is really coming together by June 1999.
